**SONIC TAGGING AND TRACKING OF  
WILD WINTER STEELHEAD AT THE BALLARD  
LOCKS, SEATTLE, WASHINGTON, SPRING 1994**

**SONIC TAGGING AND TRACKING OF WILD WINTER  
STEELHEAD AT THE BALLARD LOCKS,  
SEATTLE, WASHINGTON**

**SPRING, 1994**

**September, 1994**

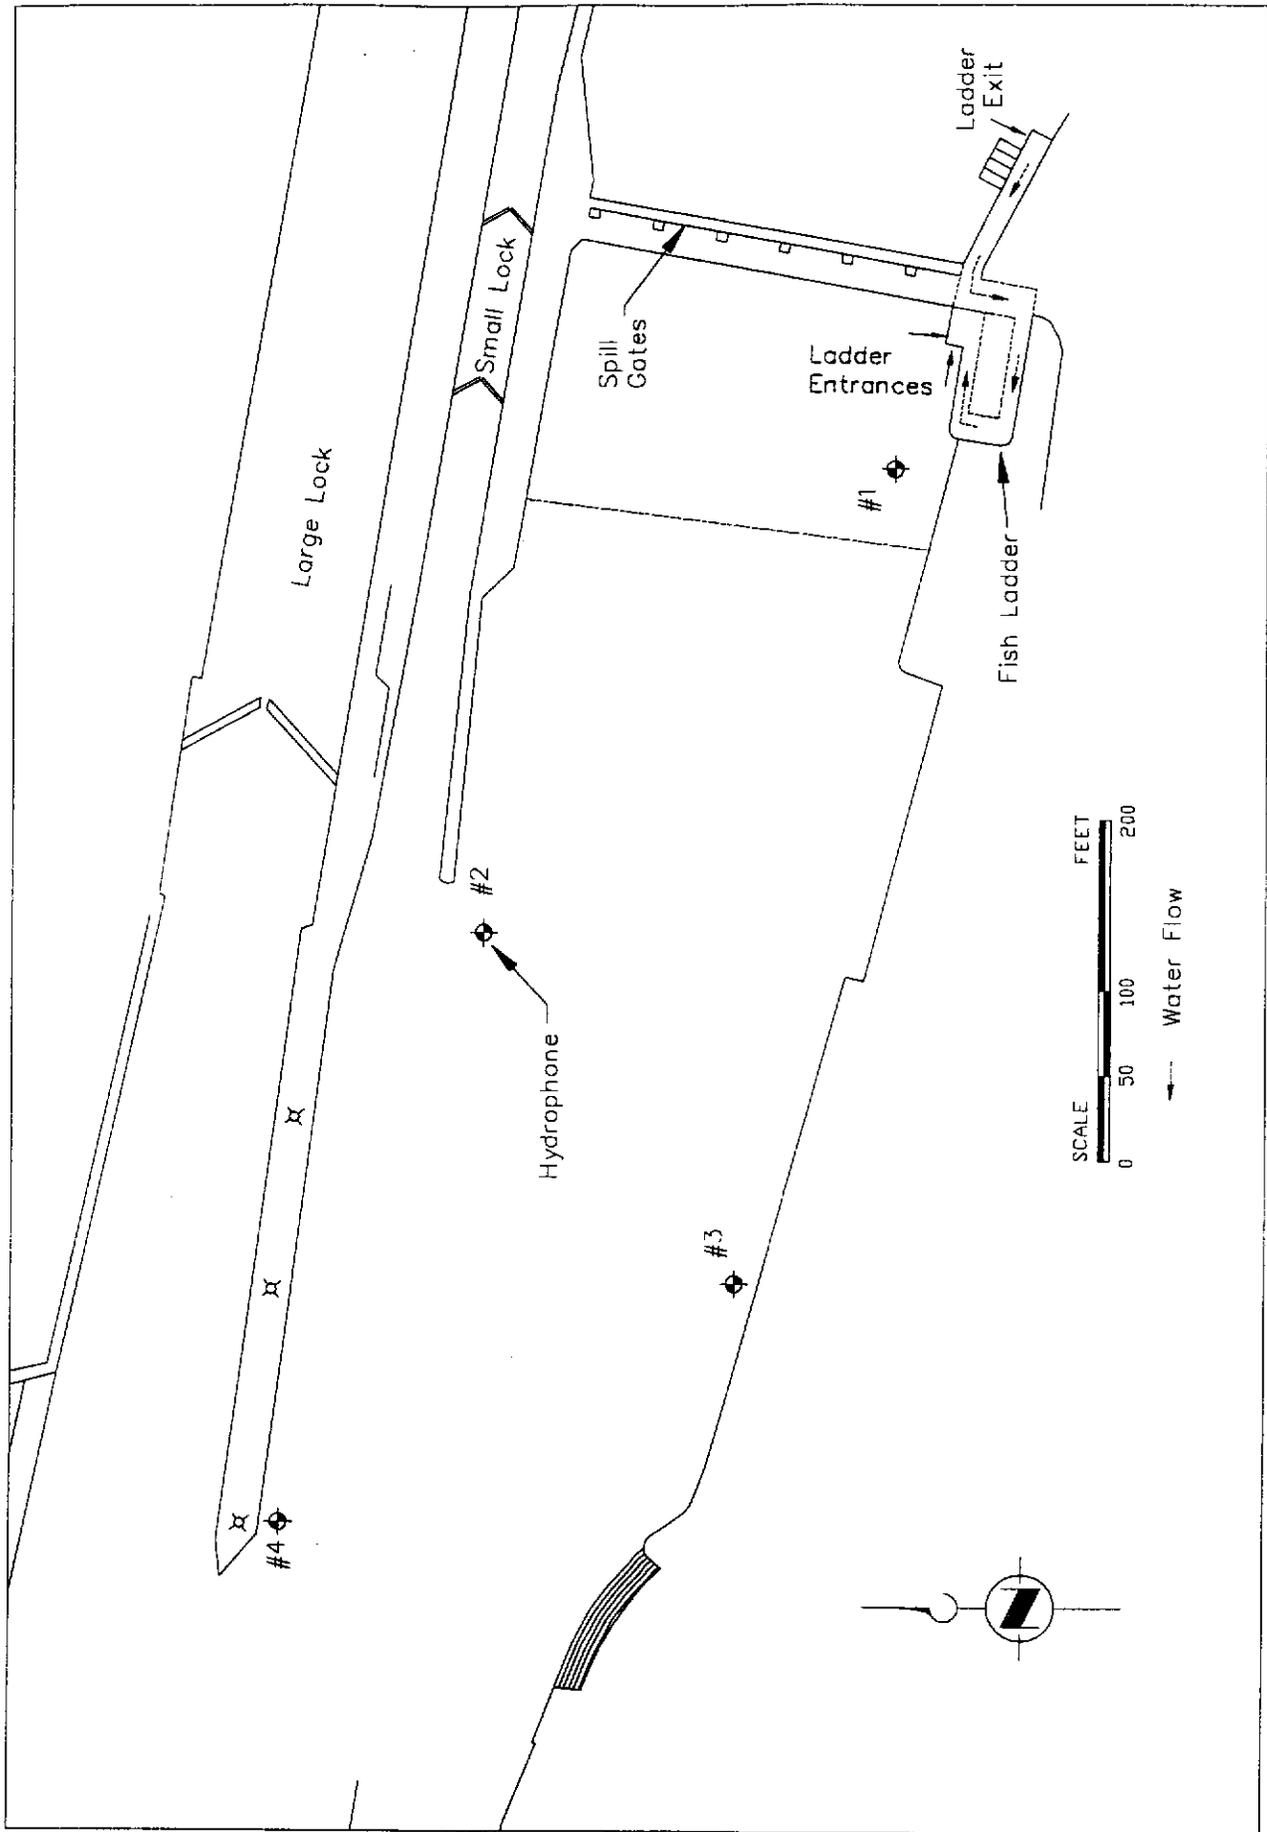
Figure 2 - Map of Ballard Locks and Hydrophone Locations.

To track steelhead movements downstream of Ballard Locks, a fixed hydrophone array system was used. The system developed by Pentec Environmental, Inc. and GRD Associates, Inc. and on loan from NMFS, Alaska Fishery Science Center consisted of an array of hydrophones and signal collection and processing hardware and software. To determine the position of the fish, differences in time between the reception of the acoustic signal from the tagged fish by one hydrophone and the reception of the signal by a minimum of two other hydrophones in the array were measured. The position of the fish was then computed from these time differences (taking into consideration the speed of sound in water) using a hyperbolic navigation algorithm (this method is similar in concept to the LORAN-C navigation system used on ships).

Using the estimated performance characteristics of the system, localization errors versus hydrophone positions were modelled prior to system deployment to determine optimal hydrophone array placement. This resulted in a compromise between desired coverage area, positioning accuracy, and the potential effects of aerated water near the spillway. Four hydrophone locations were selected to limit the geometric errors within the study area and to minimize the potential impact of aerated water near the spillway (Figure 2). Hydrophones were attached to concrete anchors and marked with buoys. Hydrophones were placed 1 m above the substrate.

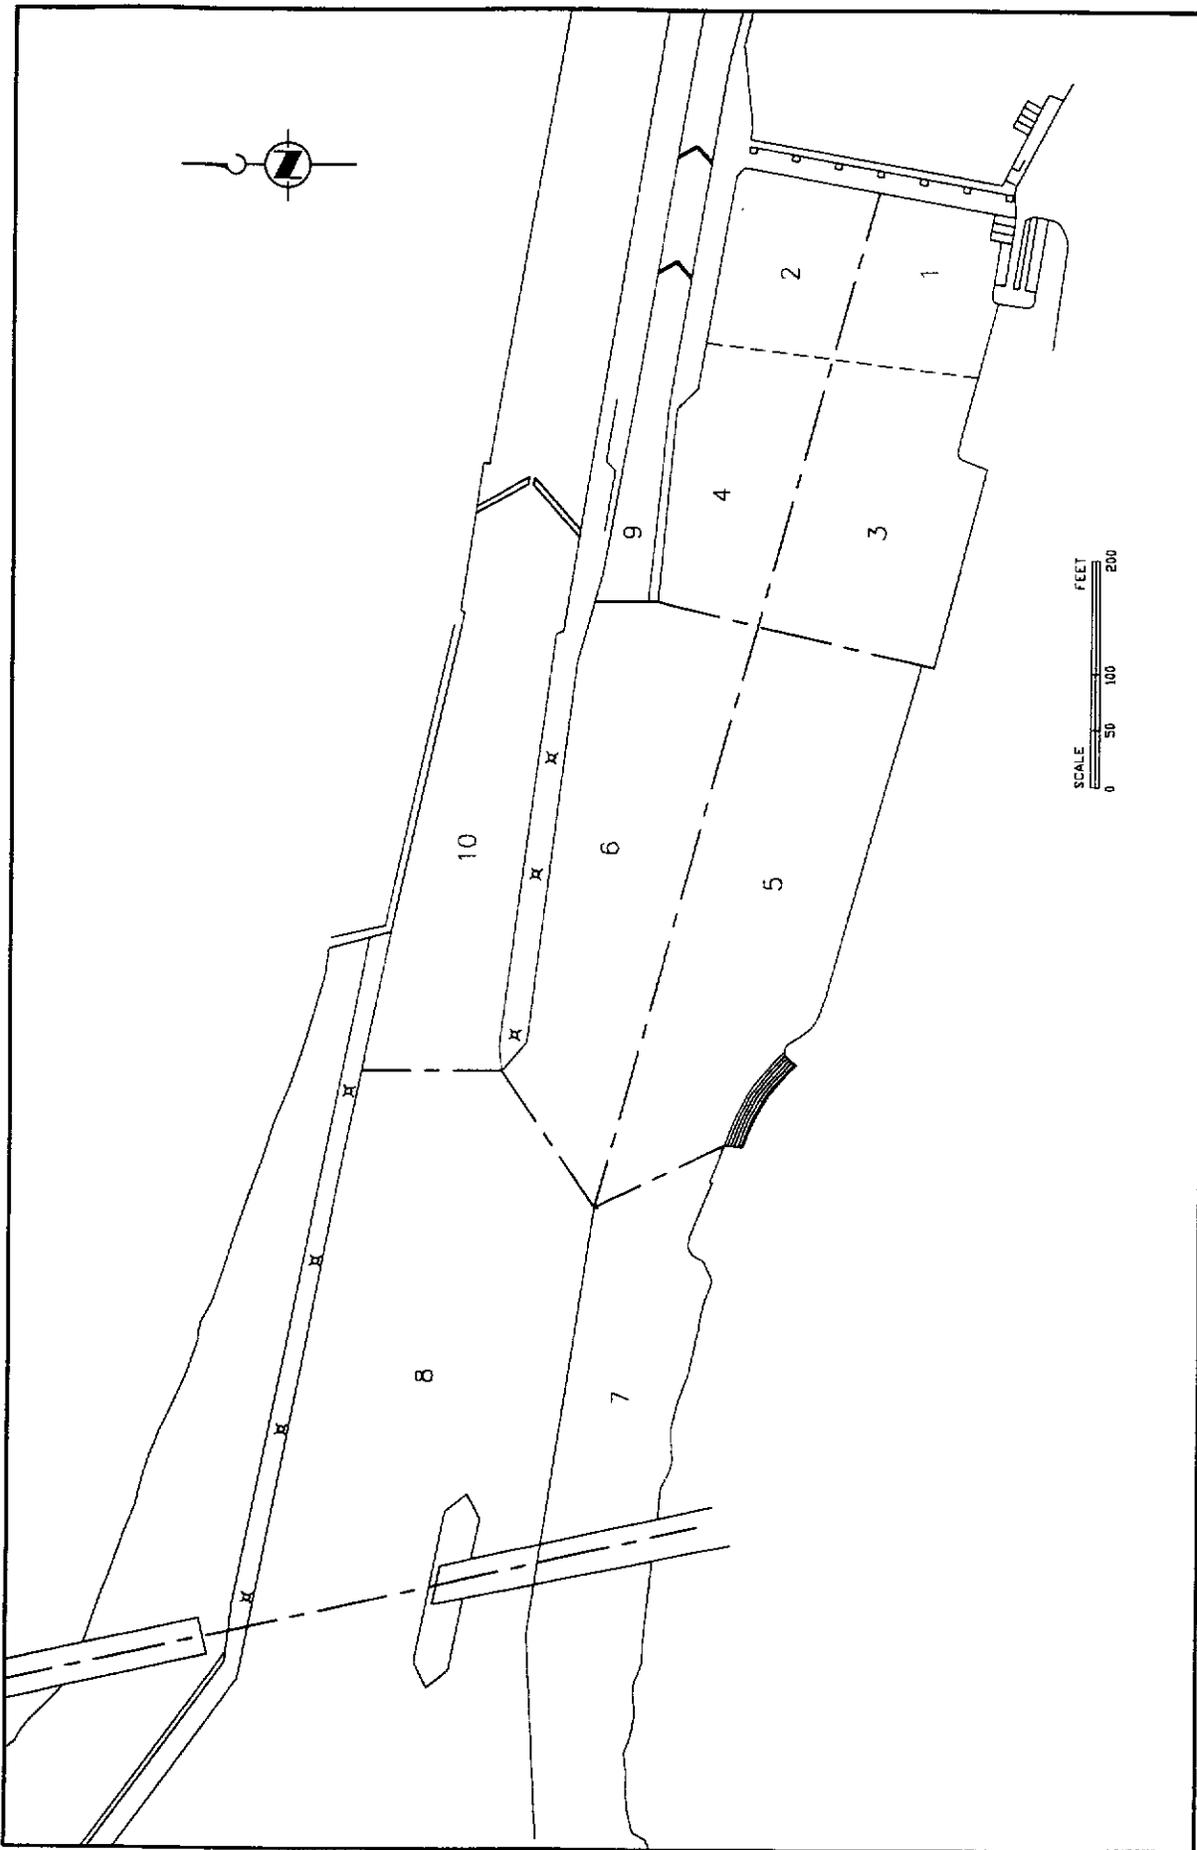
Figure 4 - Observation cells at the Ballard Locks.

then used to draw the master site map from this tracing. Since photographic images are subject to distortion, especially near the edges, due to parallax error, an Electronic Distance Measuring (EDM) laser transit was used to confirm the relative positions of key points on the map. This information was used to correct distortion in the drawing and to increase accuracy of the site map. The coordinates of the hydrophones were documented by surveying them with the EDM. Coordinates for this map were based on a local area coordinate grid system and were used only to show relative positions of objects within the study area. An increasing easting (X) value indicates movement from the west to the east. An increasing northing (Y) value indicates movement from the south to the north. To relate fish location to records of sea lion predation, the study area was also divided into 10 observational cells developed by the sea lion monitoring program (Figure 4).

**Figure 8. Percentage of time spent by tag No. 7 in observation cells at Ballard Locks. A) percentage of total time spent in observation cells near the fixed hydrophone array and B) percentage of time spent in observation cells during small lock-down lockage. Observation cells are shown in Figure 4.**

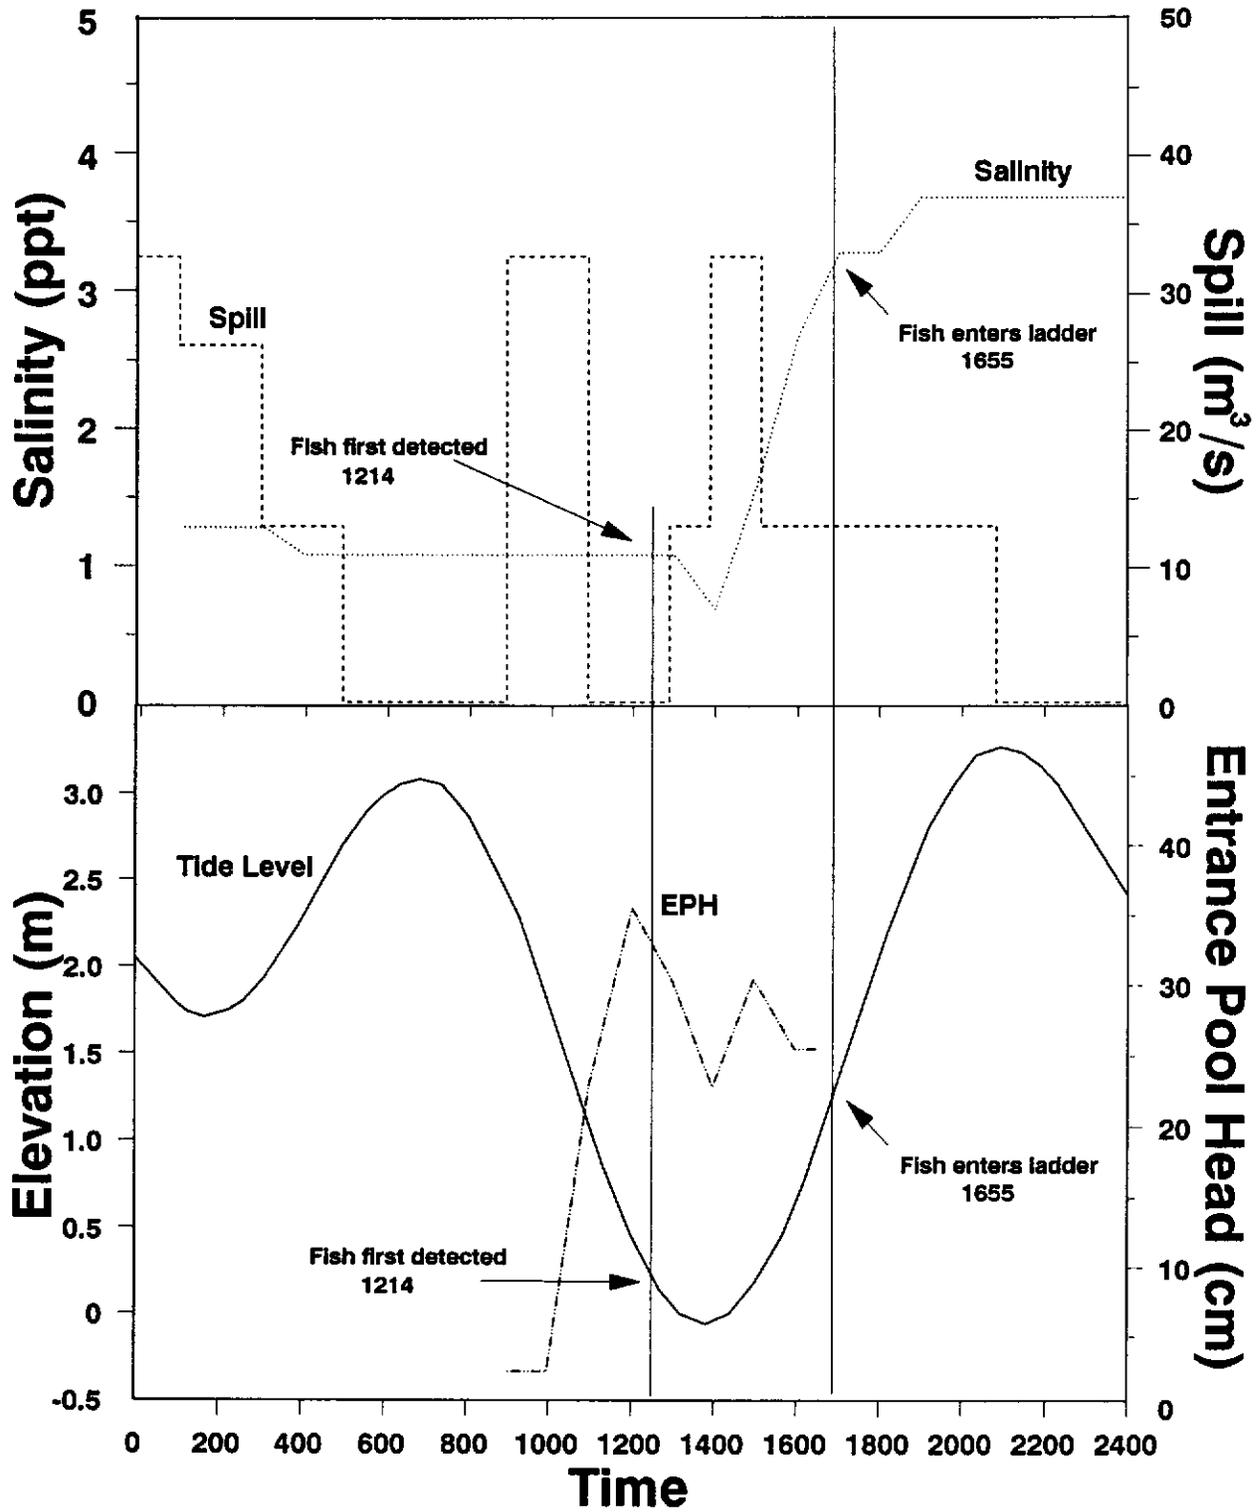
Figure 9. Relationship of salinity (entrance pool of fish ladder), spill, tide level, and entrance pool head to fish movements for Tag No. 9 on April 14, 1994.

The fish returned to the study area and passed through the fish ladder five days later on April 14. The first detection of the tag by the tracking system occurred at 1214 on hydrophones 3 and 4. This was prior to ebb slack tide at 0.38 m (Figure 9). The signal from the tag was erratically detected by one or two hydrophones with several detection gaps occurring until 1634 hrs when the signal was finally lost. No position data could be obtained due to turbulent water conditions. The length of time between the first detection of the tag and when the fish was detected in the fish ladder at 1655 was 4 h and 41 min. During this time interval, spill volume varied from 0 to 32.5 m<sup>3</sup>/s (Table 9). Entrance pool head was visually estimated and varied from 35 to 26 cm (Figure 9).

The fish entered the ladder on the flooding tide at 1.28-m msl and salinity in the entrance pool to the fish ladder was relatively low (Figure 9). Spill volume was 13.0 m<sup>3</sup>/s (the second and third gates closest to the fish ladder were each open 0.15 m) when the fish entered the ladder. The tag was detected in lower fish ladder for 9 min ending at 1704. The hydrophone in the viewing chamber then picked up the signal between 1744 and 1754. Next, the tag was detected upstream of the fish ladder from 1757 to 1821 and from 1845 to 1909. Total transit time through the ladder was 1 h and 2 min.

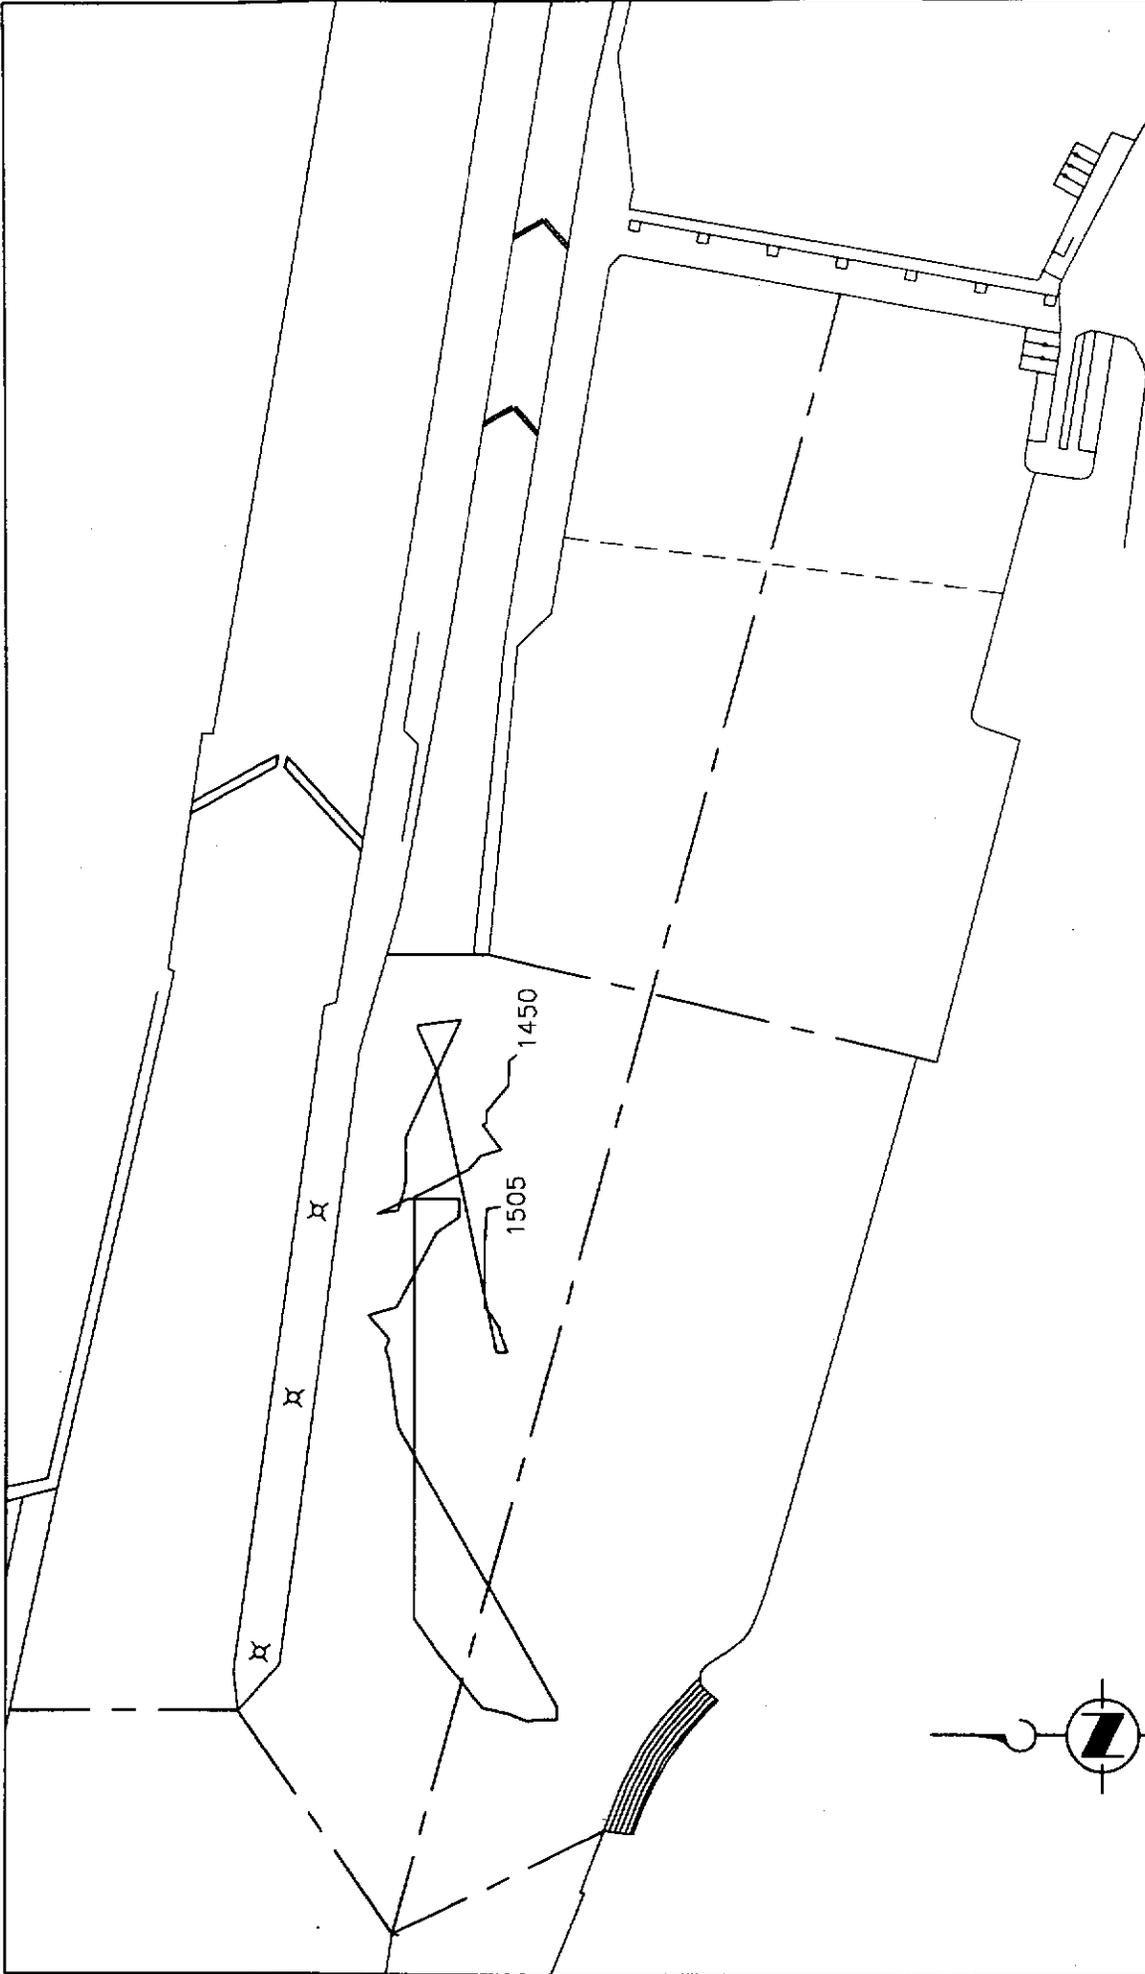
**BALLARD LOCKS**  
 Plot 7  
 Position of 63.6 kHz tag  
 From 1450 to 1505 on April 2, 1994

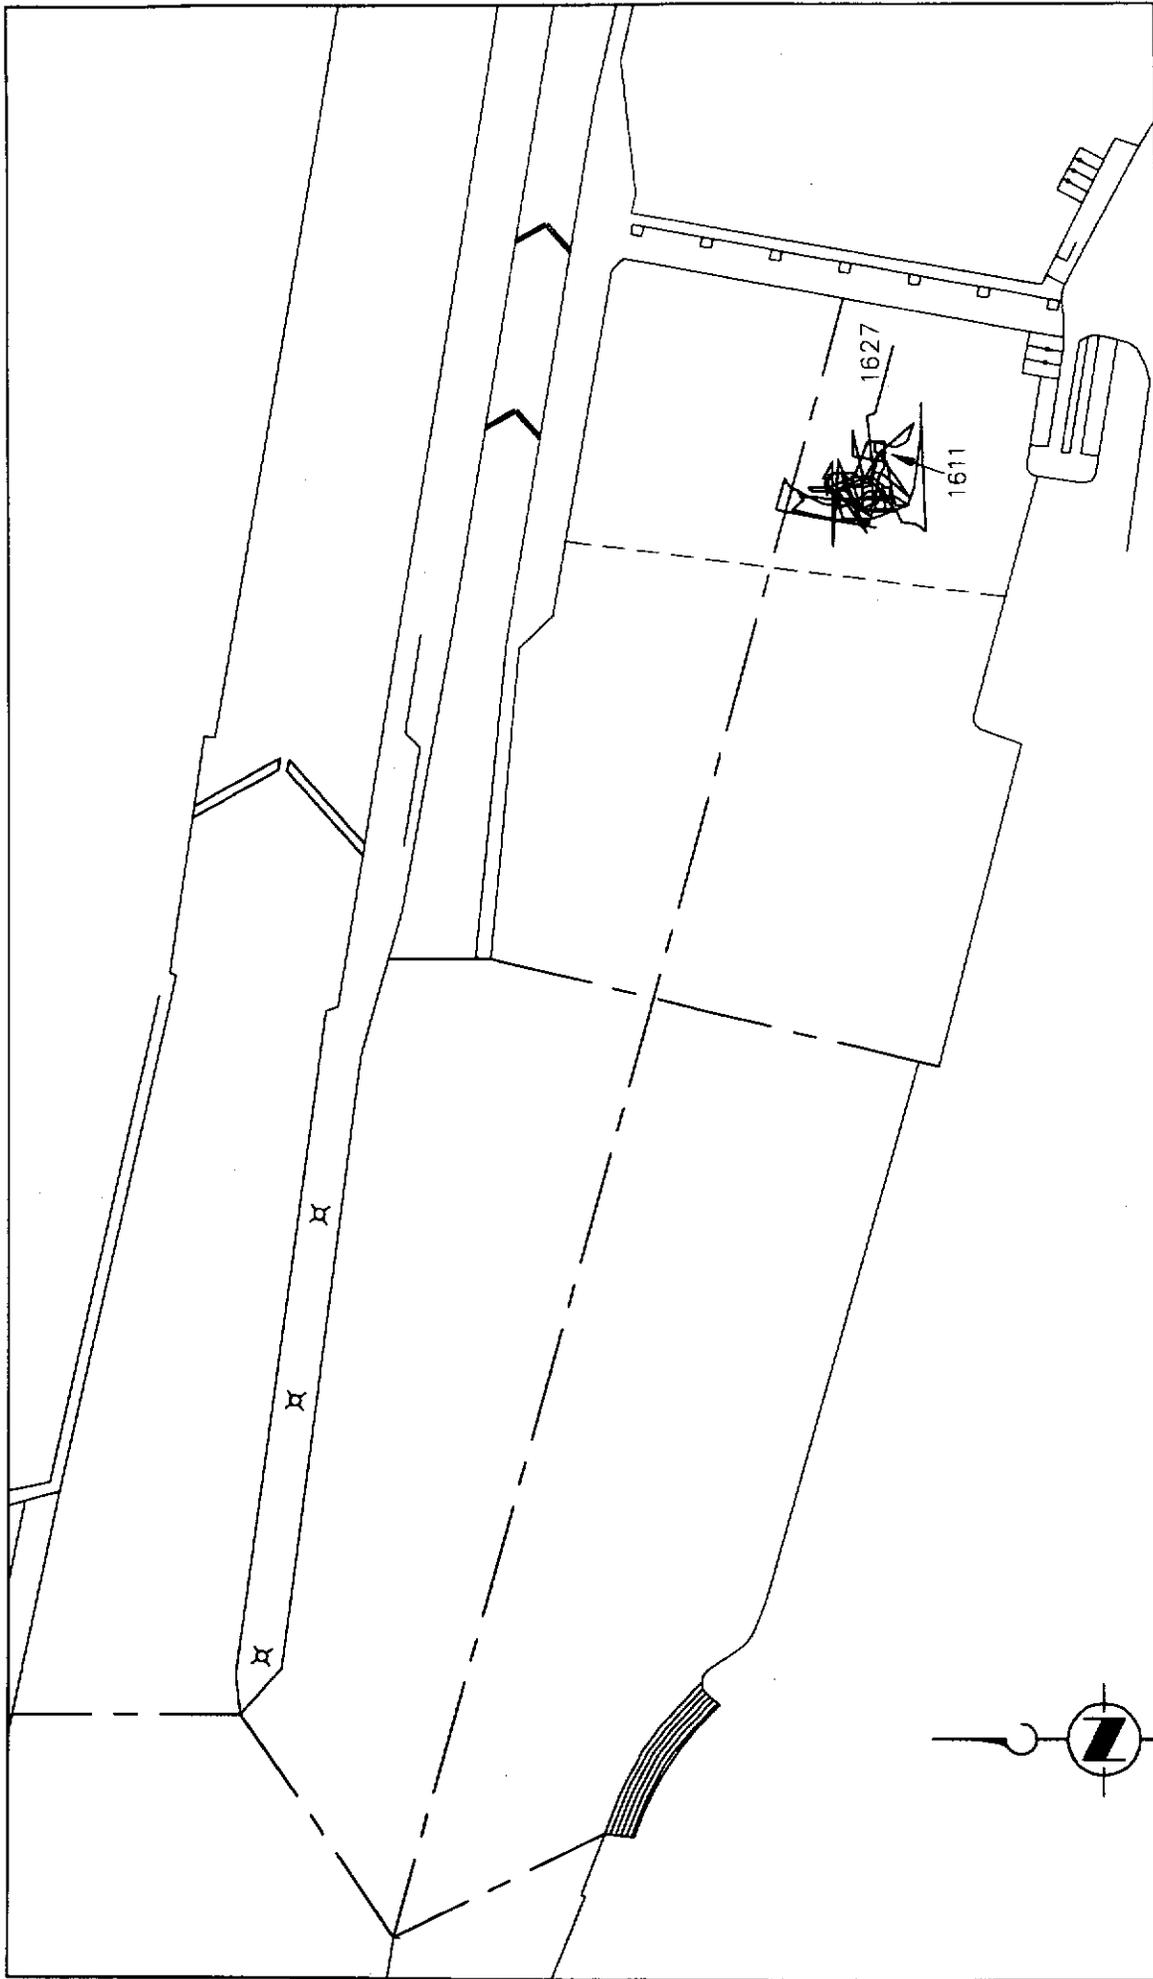
BALLARD LOCKS  
Plot 10  
Position of 63.6 kHz tag  
From 1611 to 1627 on April 2, 1994

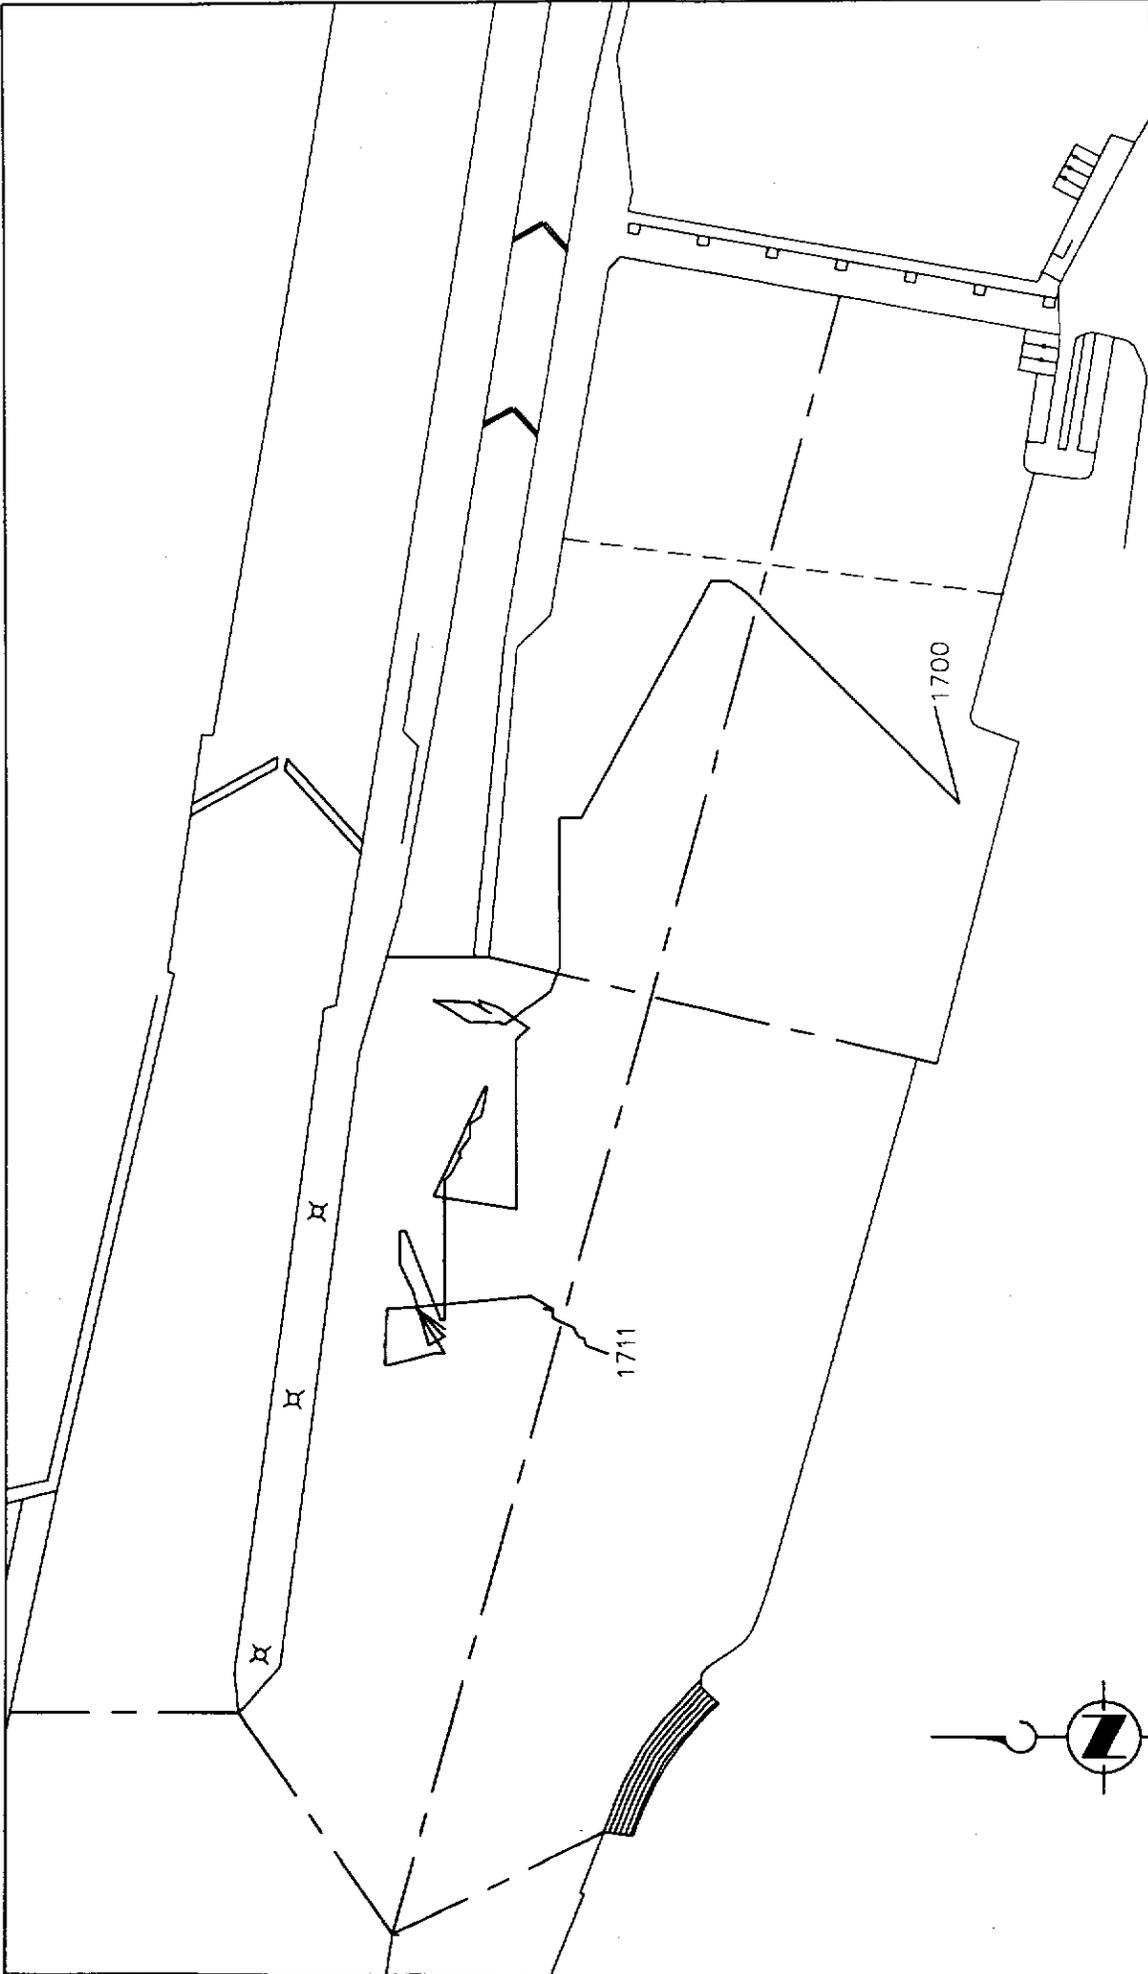
BALLARD LOCKS  
Plot 13  
Position of 63.6 kHz tag  
From 1700 to 1711 on April 2, 1994  
**Pentec** ENVIRONMENTAL  
Pentec Environmental, Inc.  
Edmonds, WA 98020

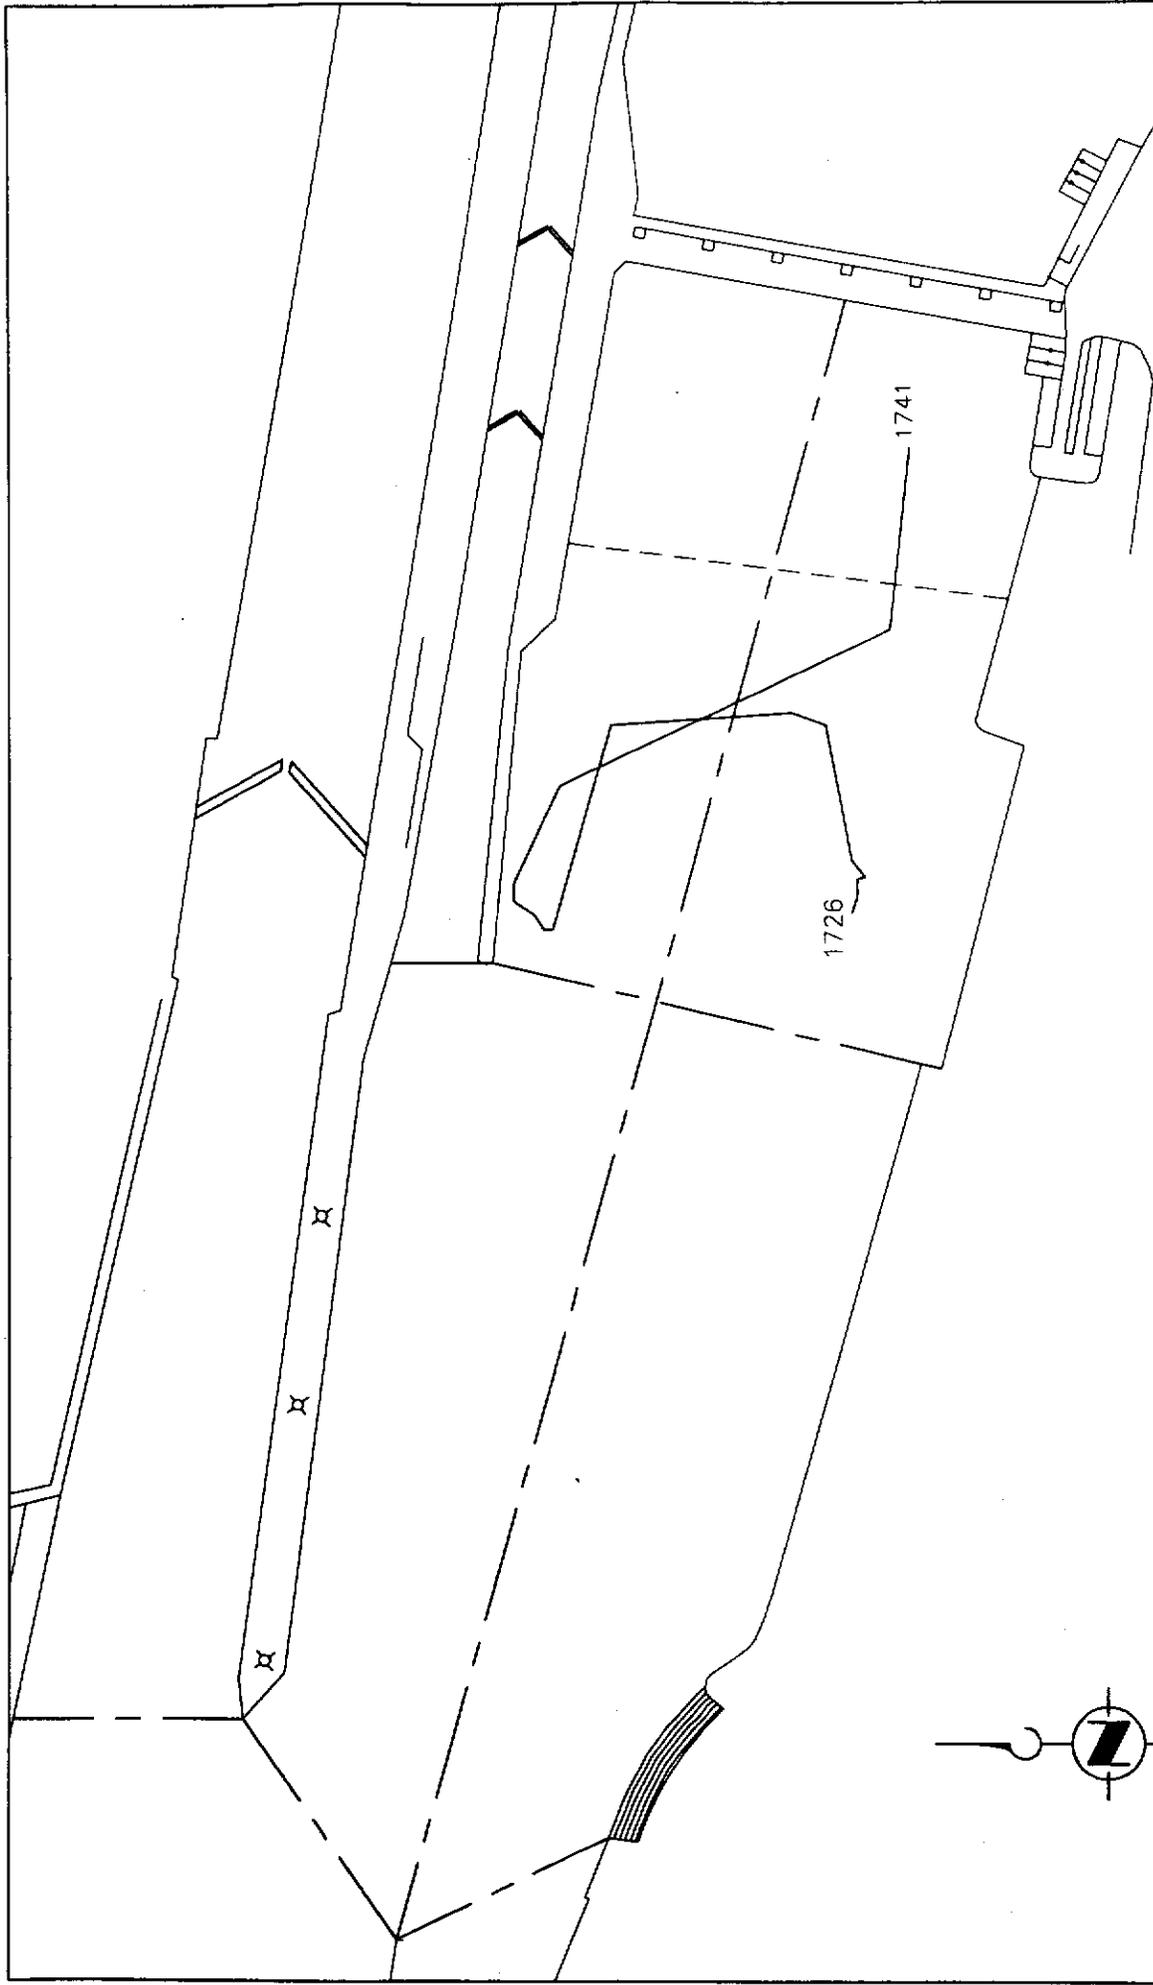
Plot 15  
Position of 63.6 kHz tag  
From 1726 to 1741 on April 2, 1994

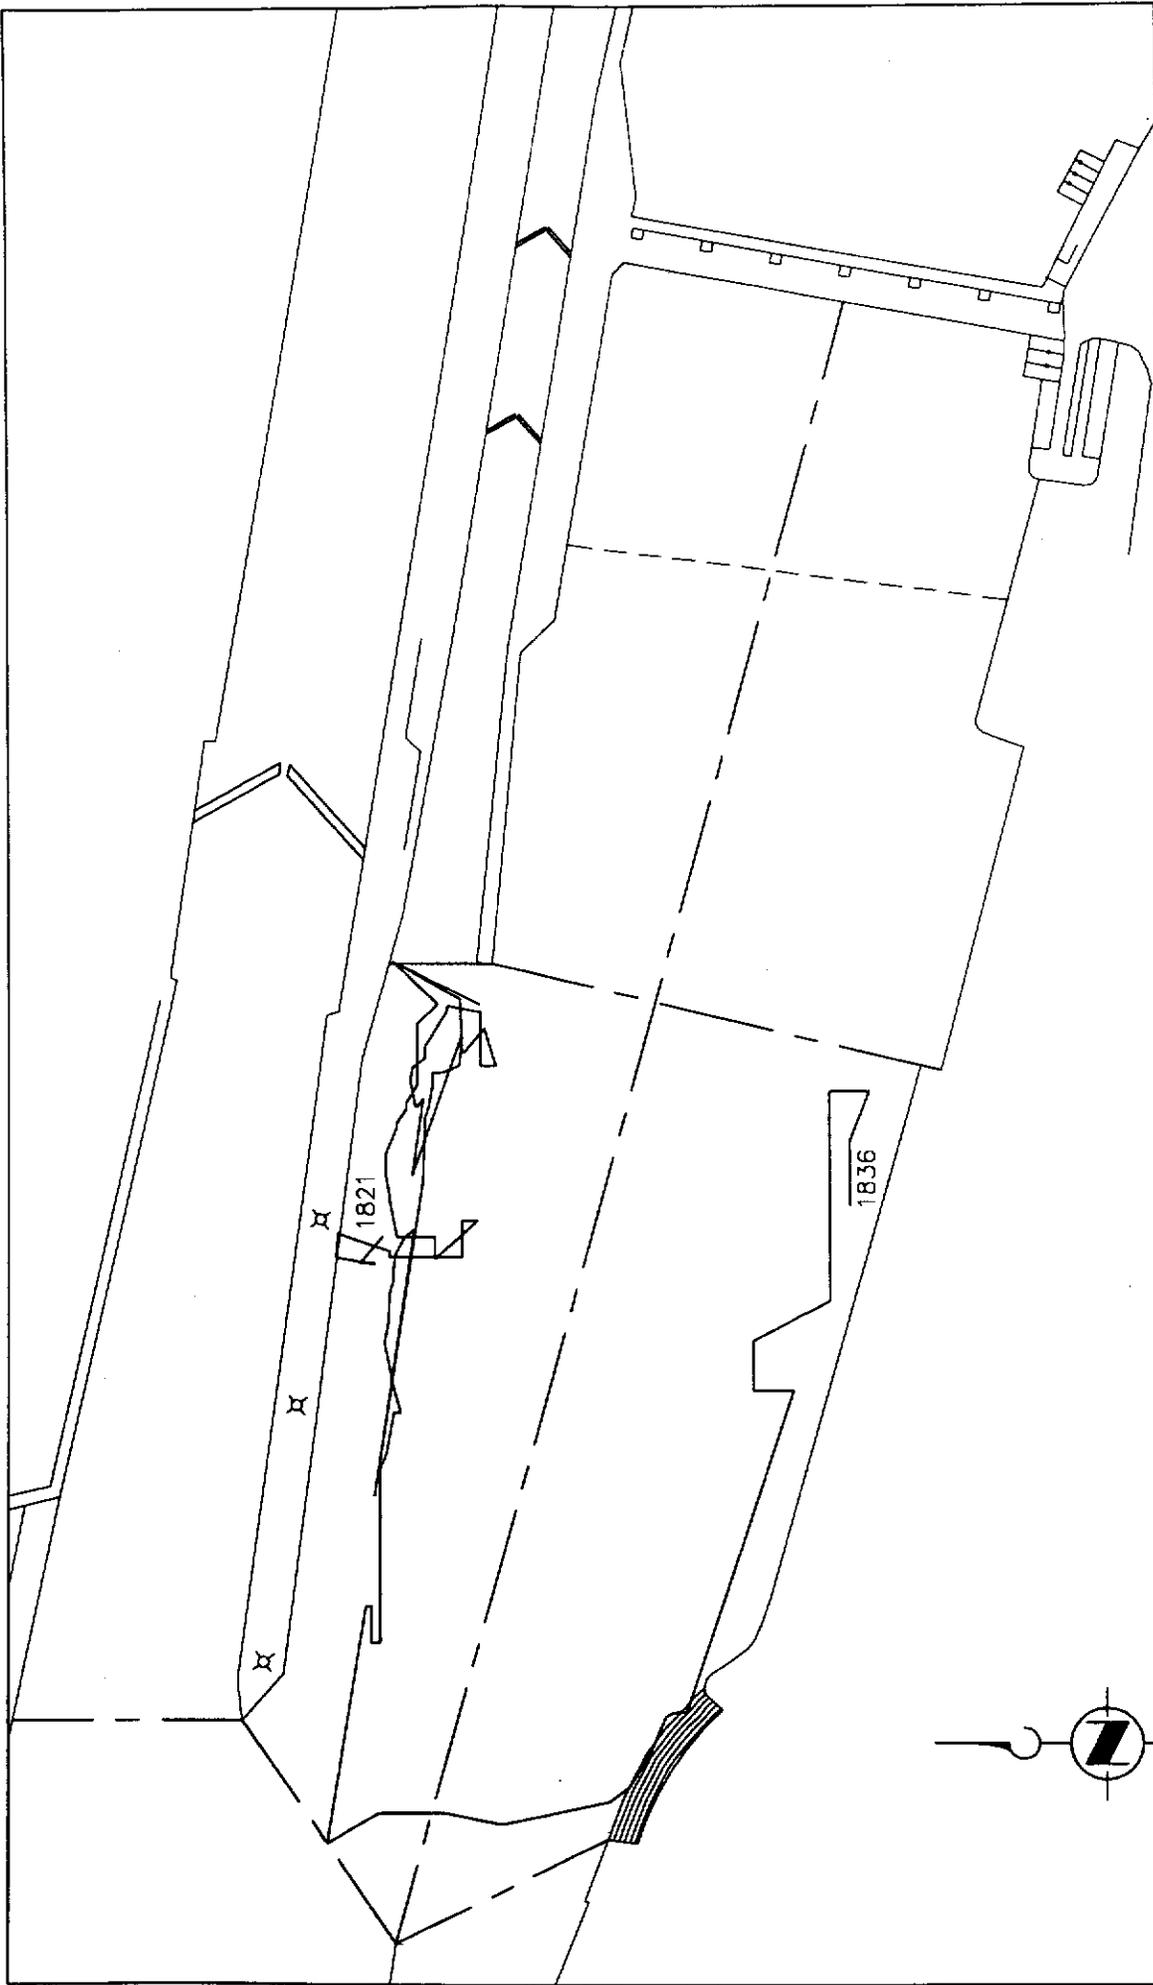
Plot 18  
Position of 63.6 kHz tag  
From 1821 to 1836 on April 2, 1994

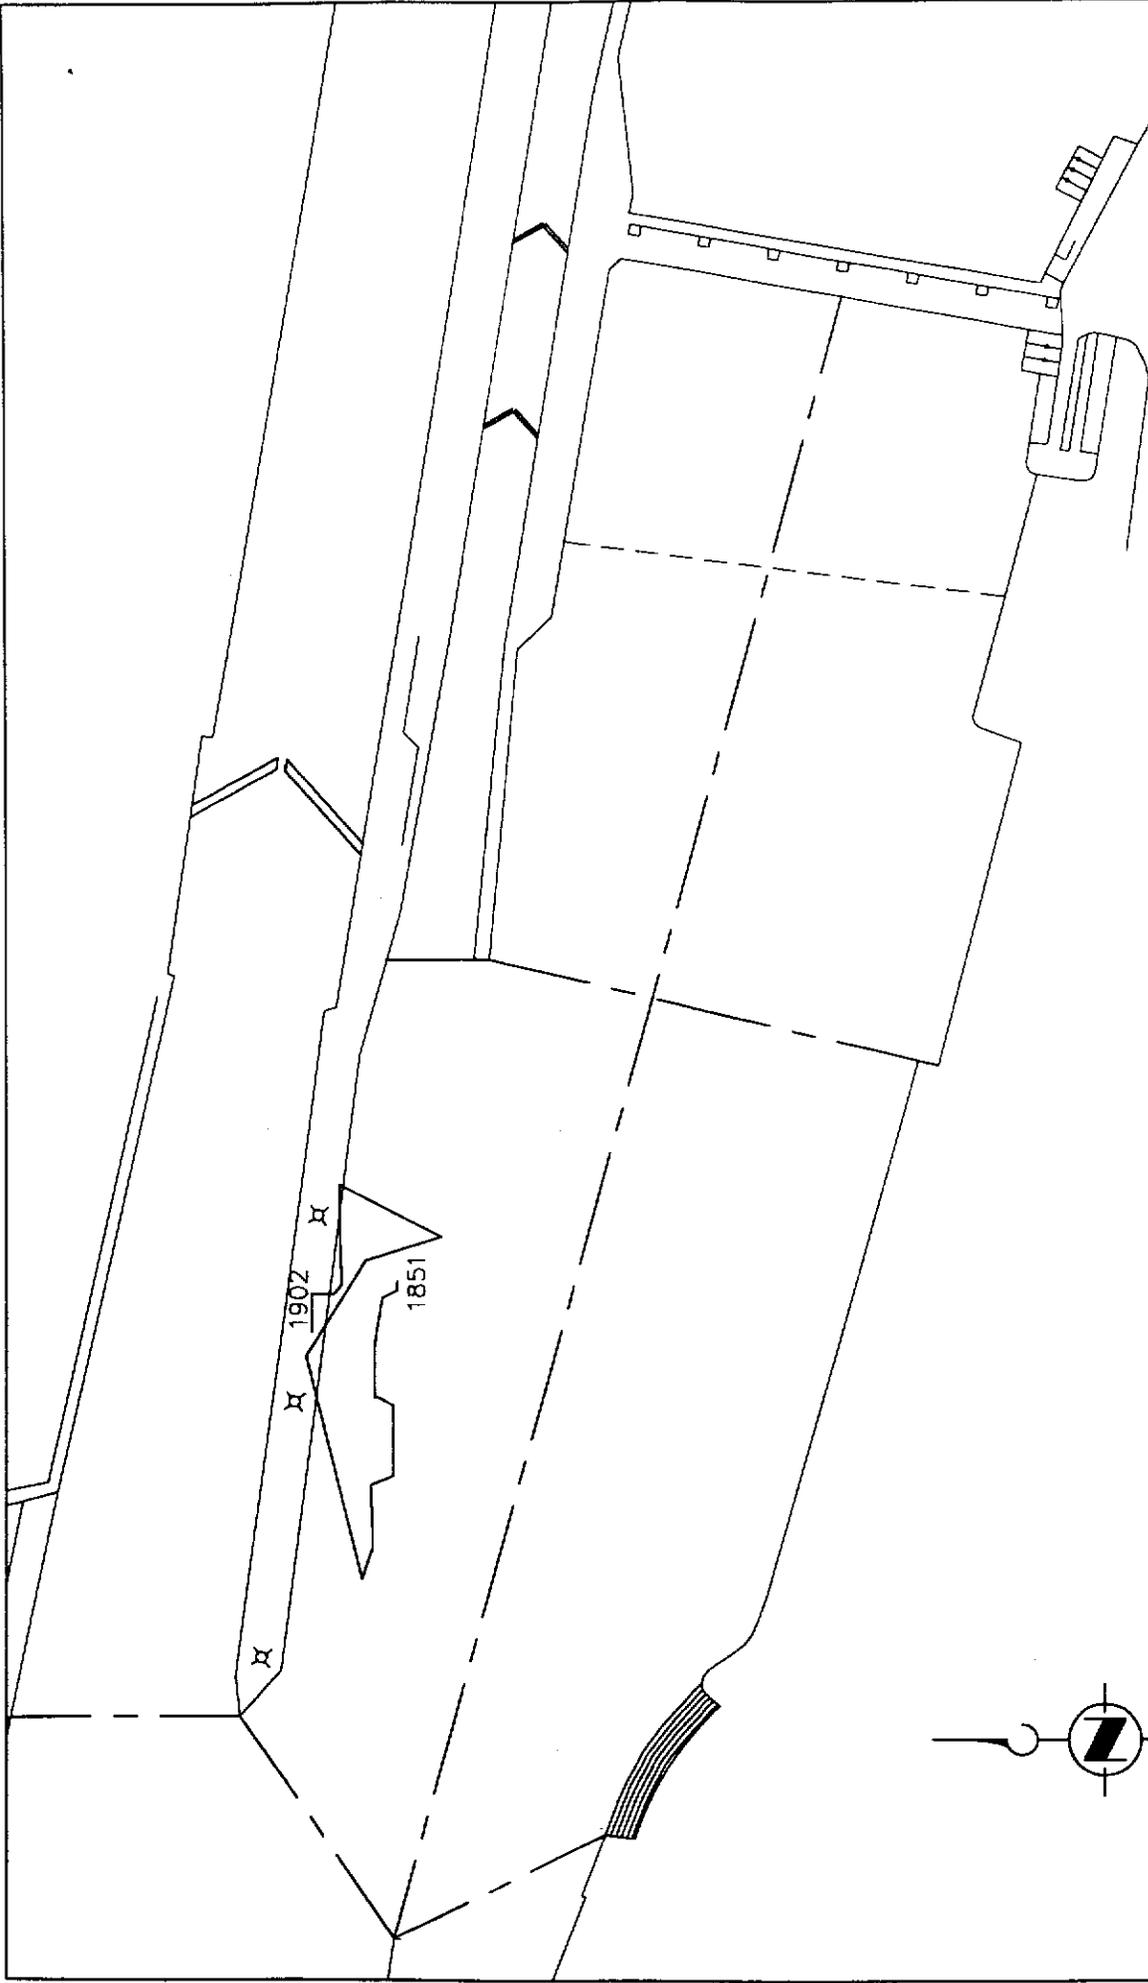
Plot 20  
Position of 63.6 kHz tag  
From 1851 to 1902 on April 2, 1994
