**SONIC TAGGING AND TRACKING OF  
WILD WINTER STEELHEAD AT THE BALLARD  
LOCKS, SEATTLE, WASHINGTON, SPRING 1994**

**SONIC TAGGING AND TRACKING OF WILD WINTER  
STEELHEAD AT THE BALLARD LOCKS,  
SEATTLE, WASHINGTON**

**SPRING, 1994**

**September, 1994**

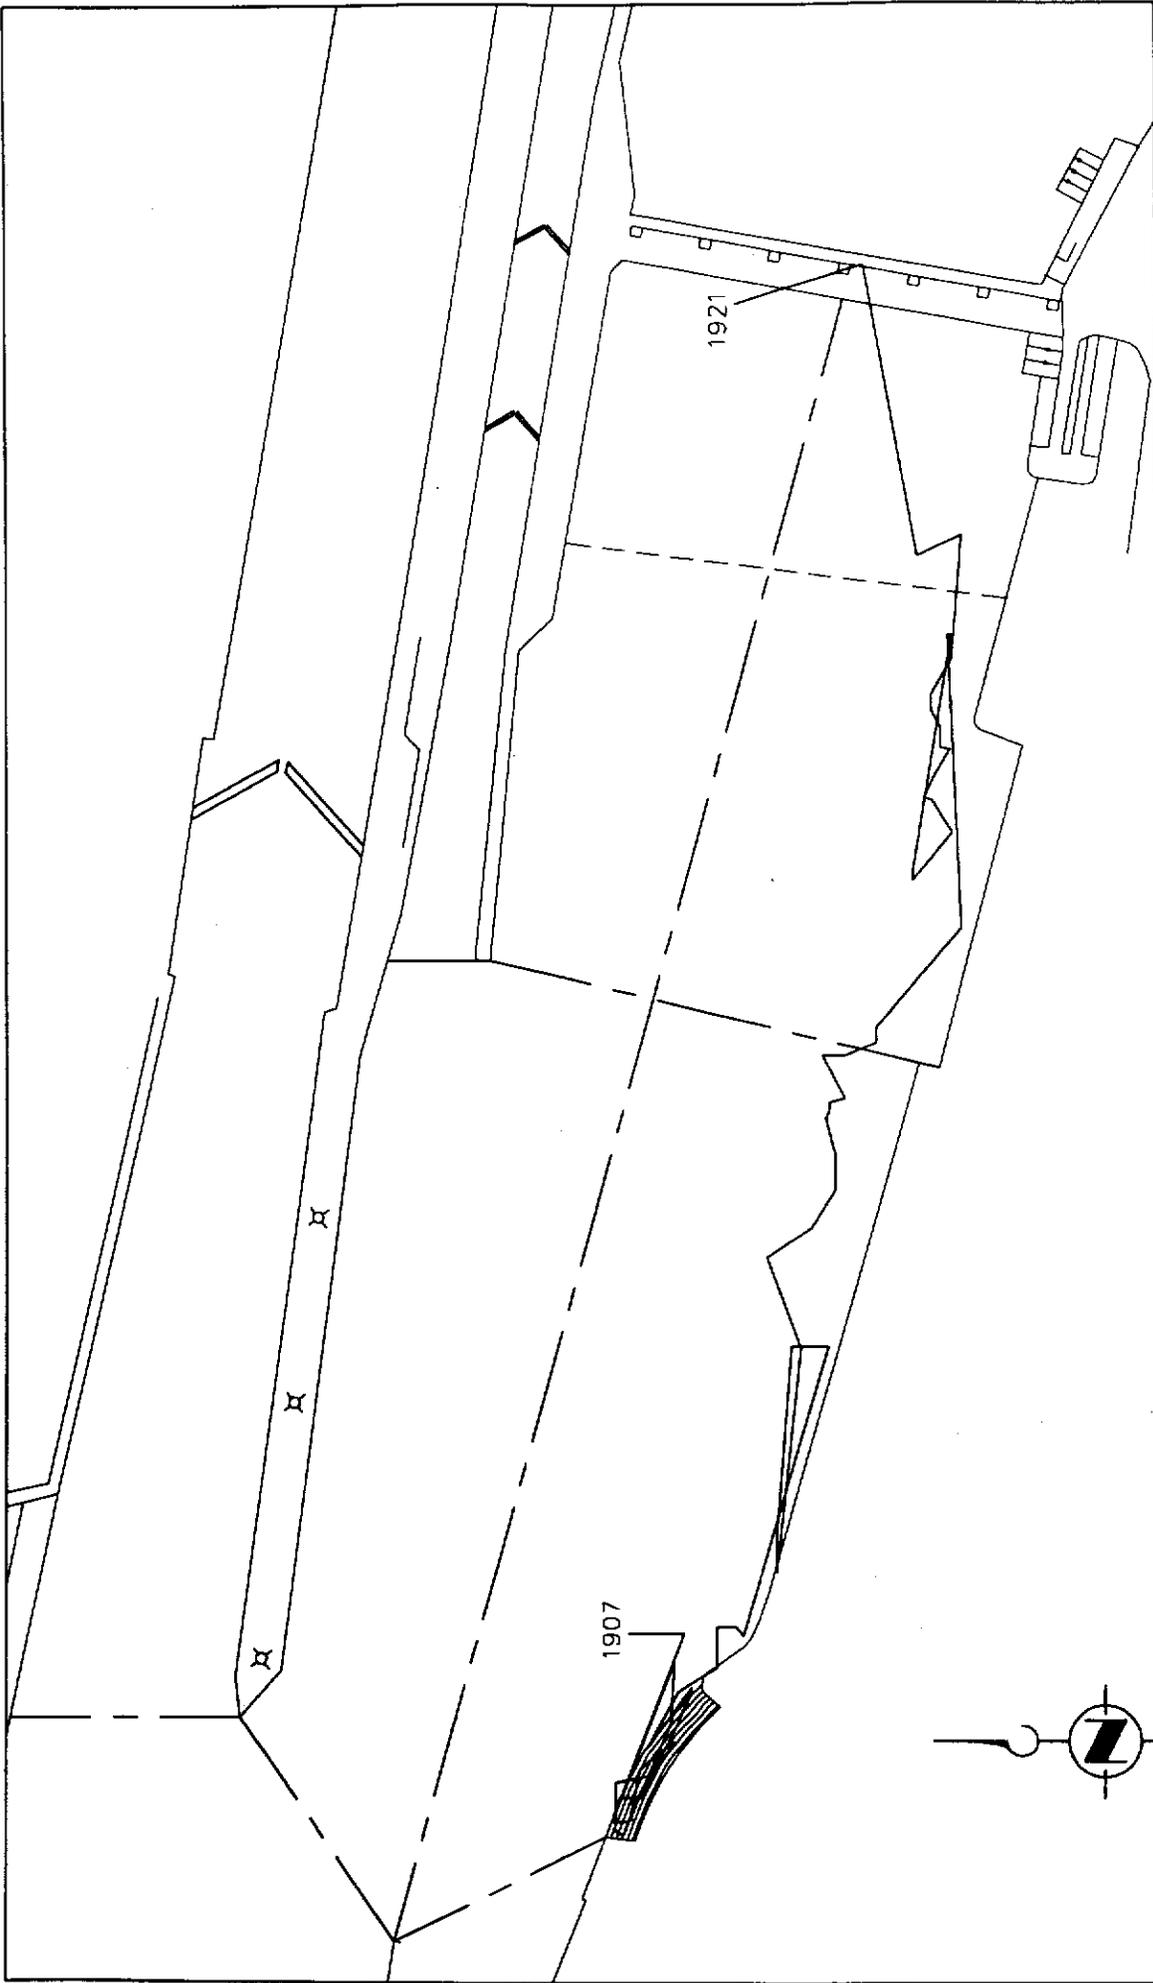
Plot 21  
Position of 63.6 kHz tag  
From 1907 to 1921 on April 2, 1994

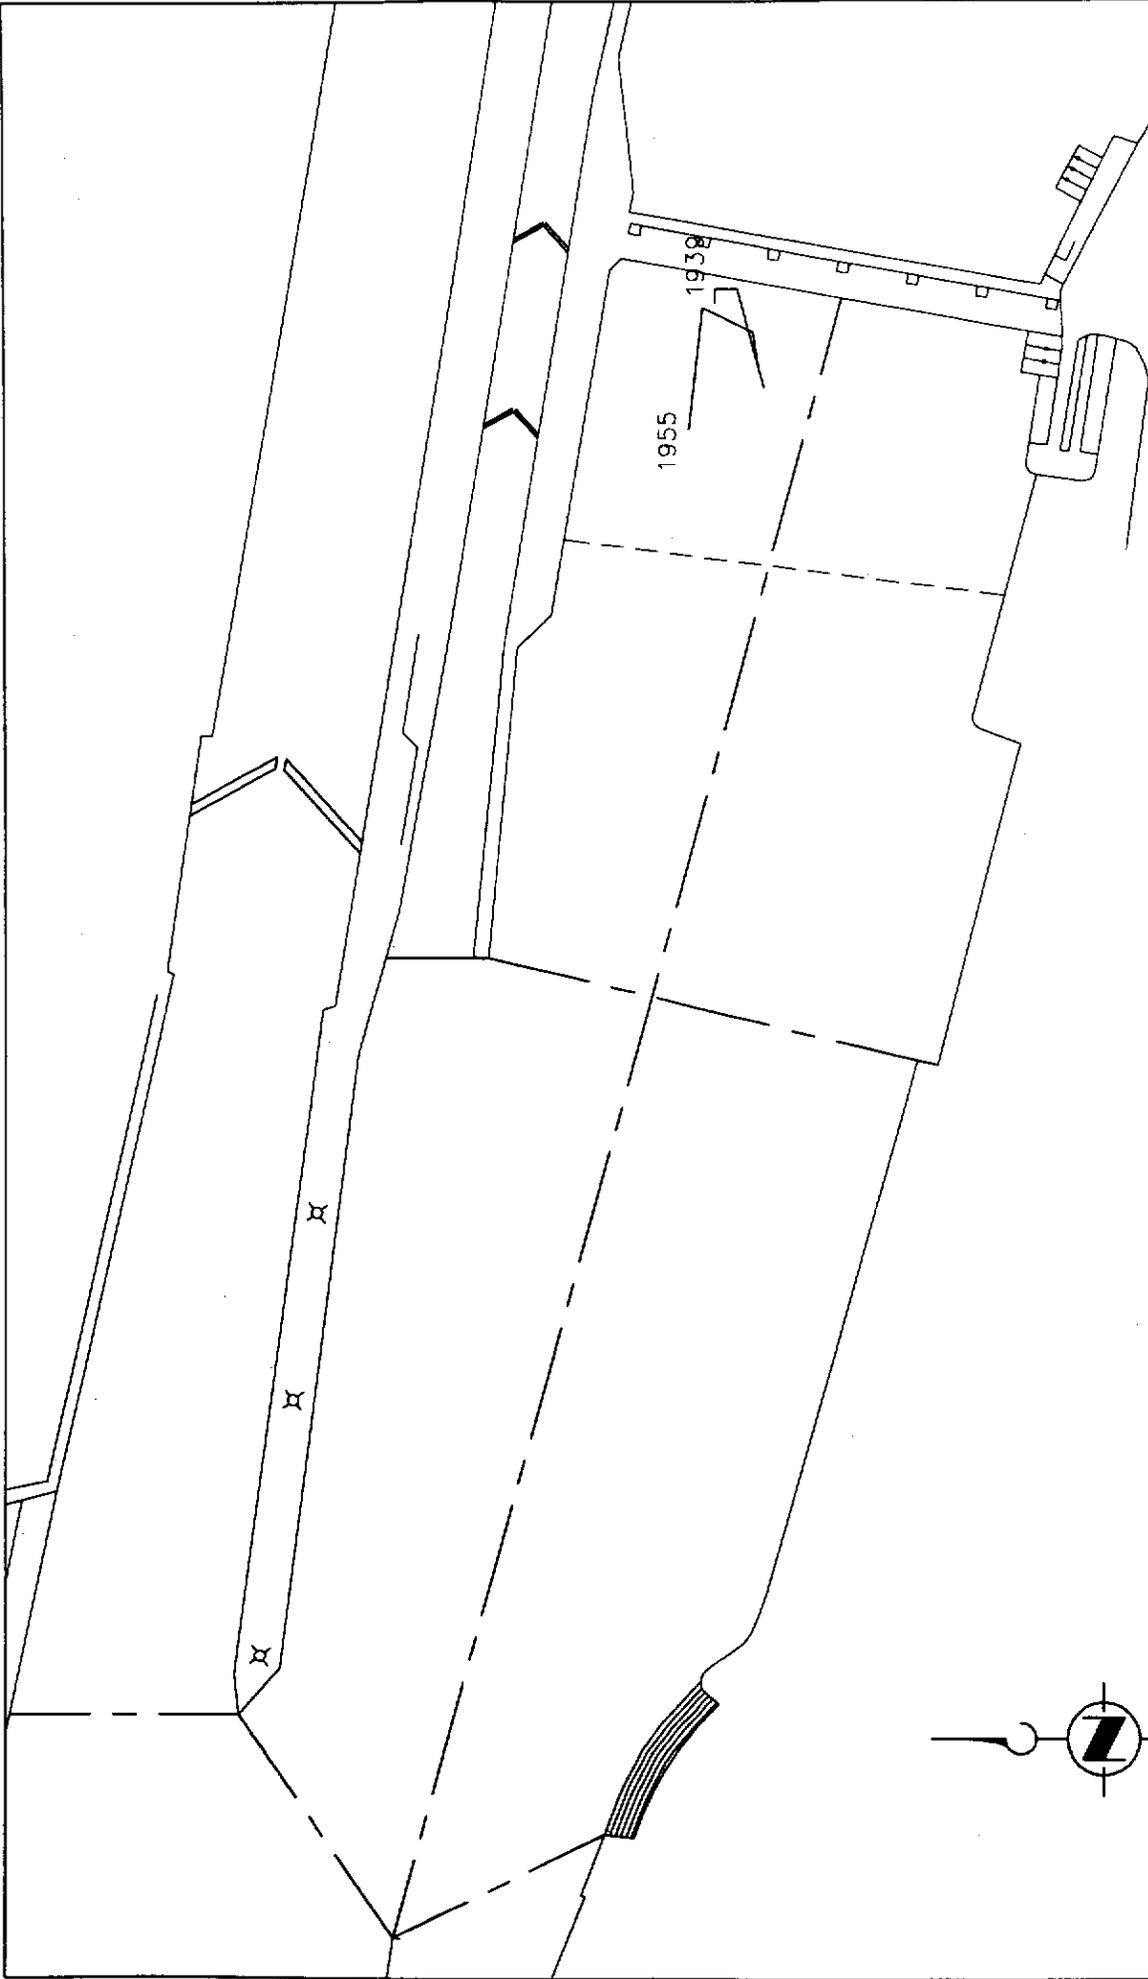
Plot 22  
Position of 63.6 kHz tag  
From 1939 to 1955 on April 2, 1994

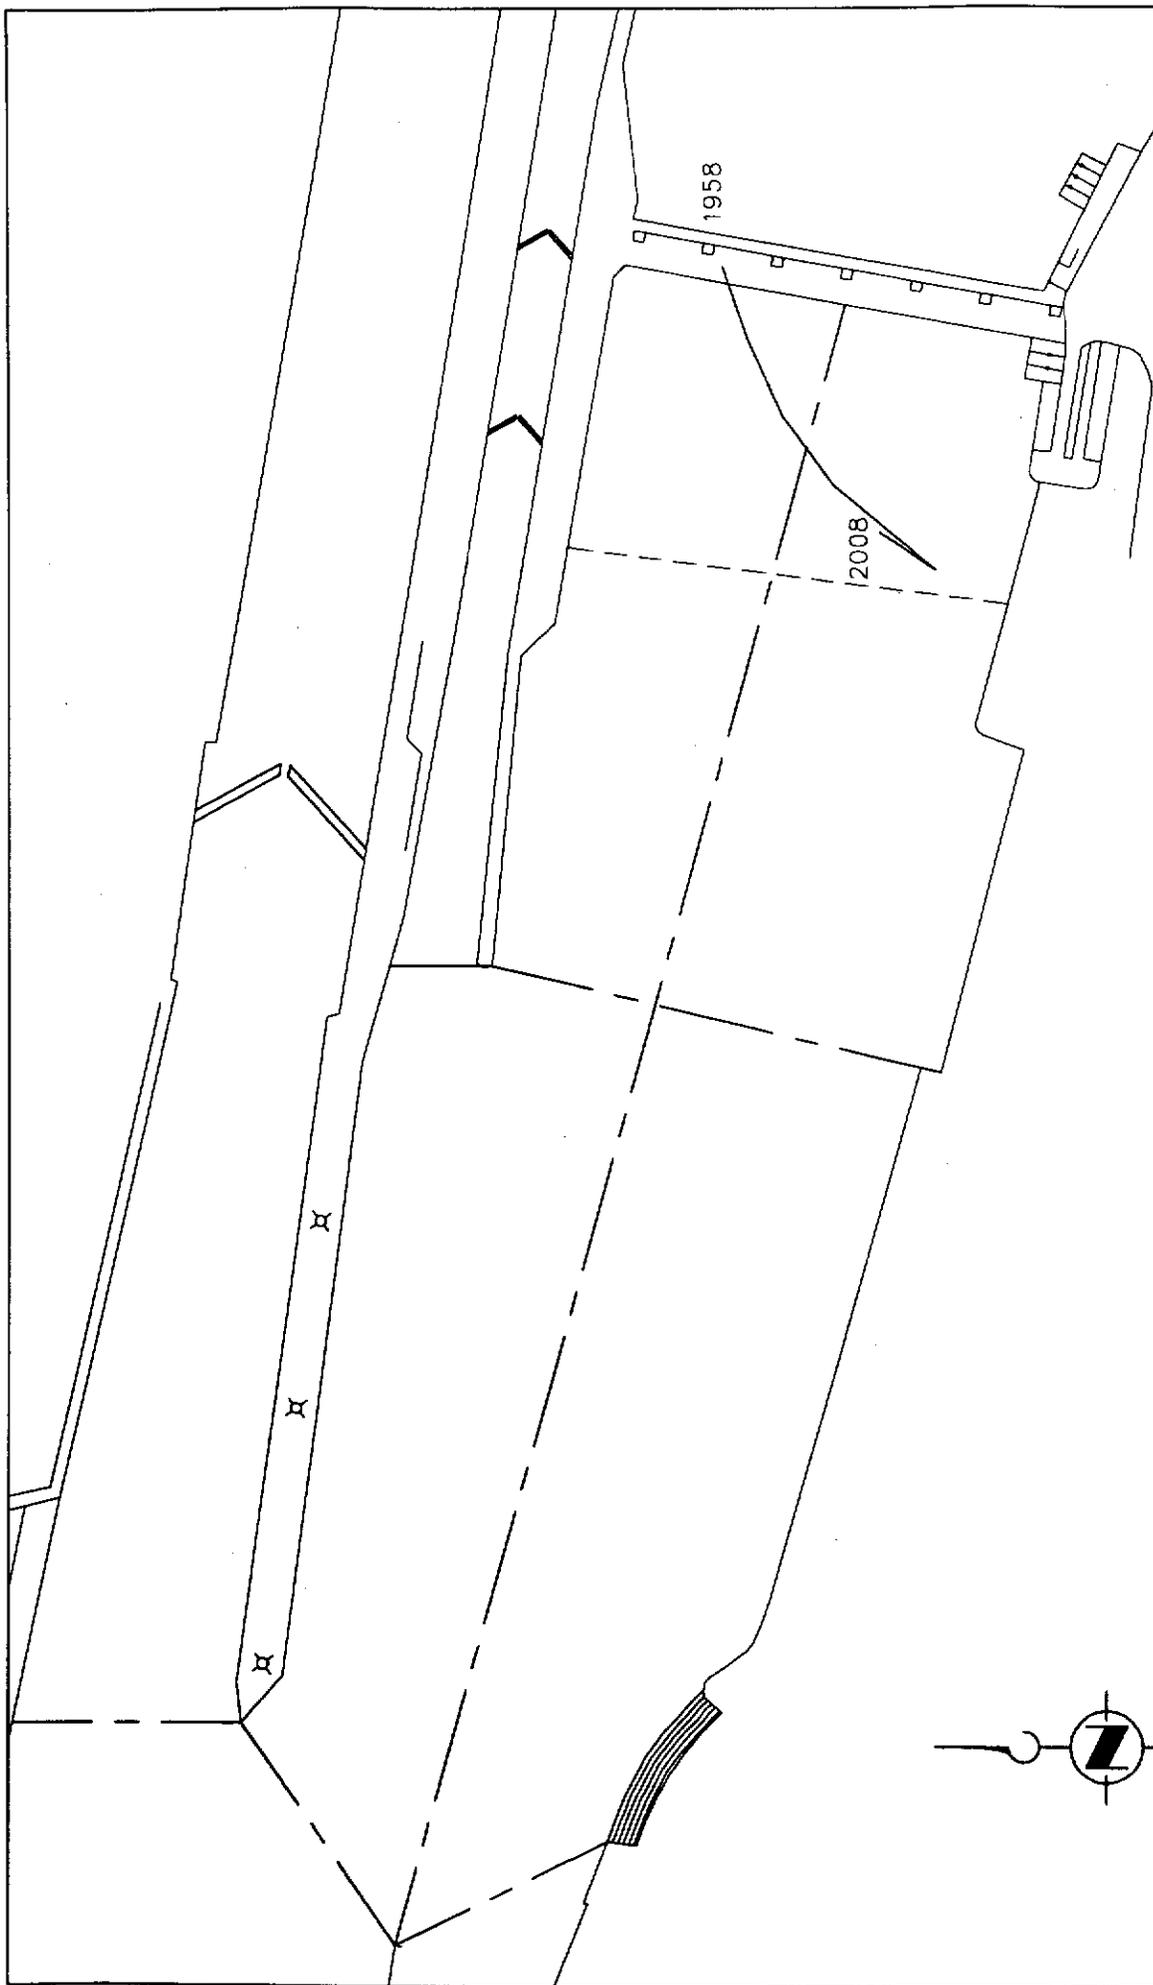
Plot 23  
Position of 63.6 kHz tag  
From 1958 to 2008 on April 2, 1994
